1. Project Name: Rota SBH

2. Date of Inspection: September 18, 2004

4. Discussion:

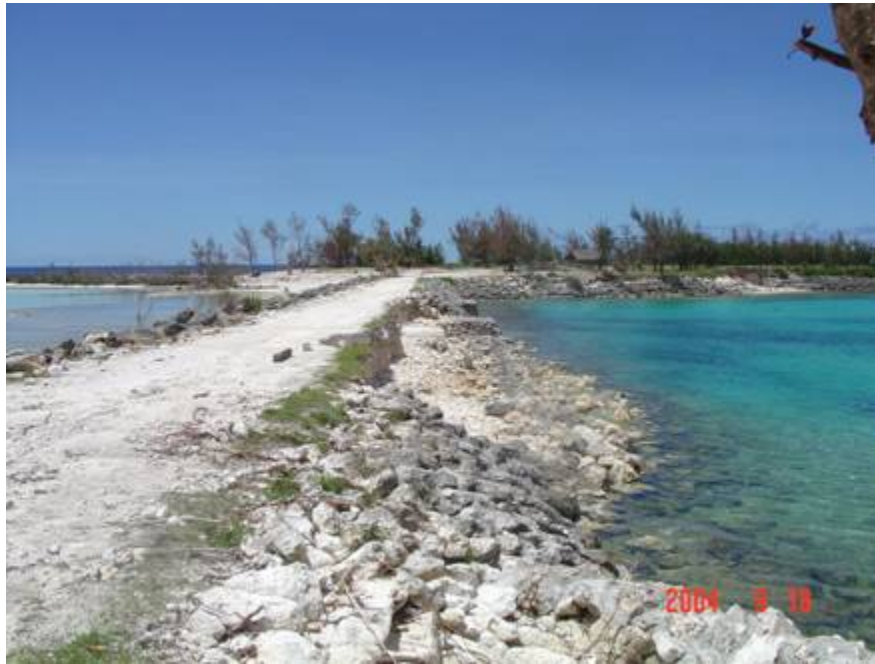
a. Sta. 0+00, HS, Overview of damages.

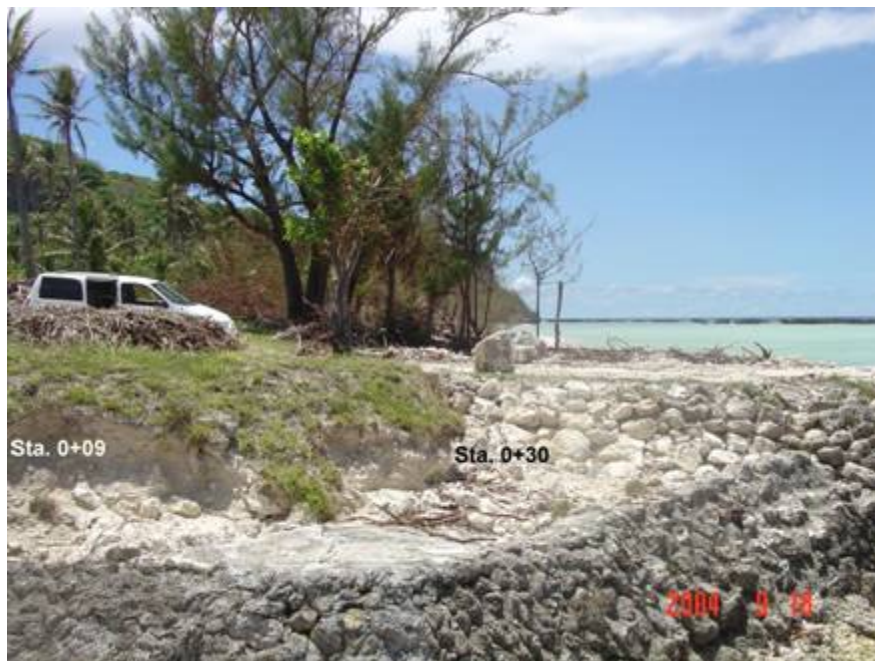
b. Sta. 0+09 to Sta. 0+30, HS, Erosion to existing sideslope, repairs required.

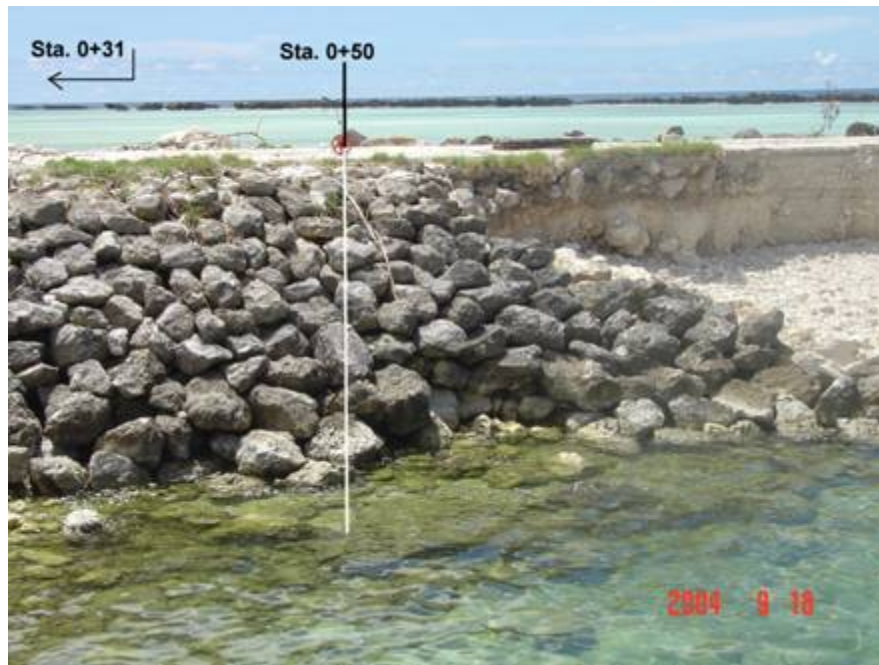
c. Sta. 0+50, HS, Beginning of major damages to the sideslope.

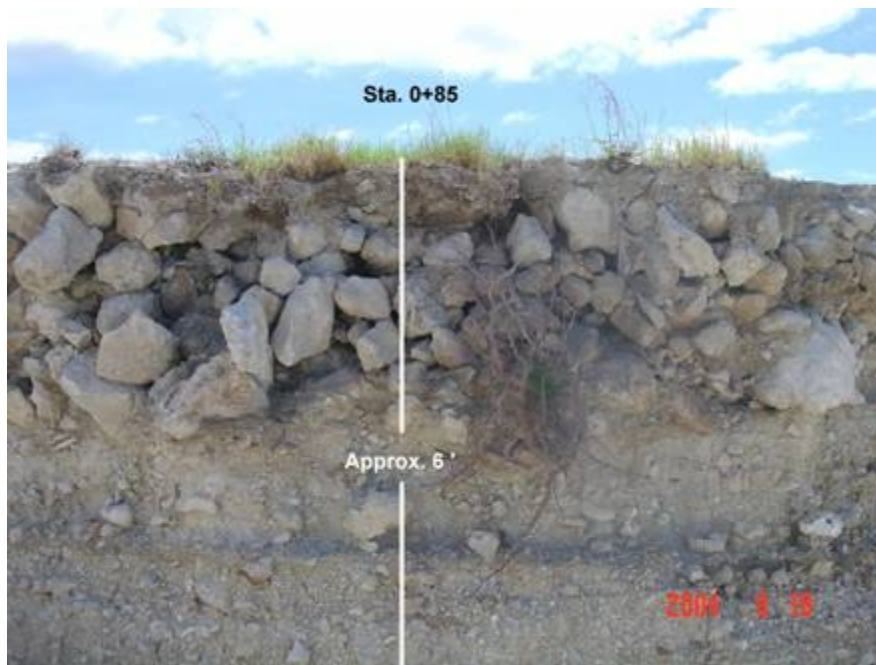
c. Sta. 0+85, HS, the depth of washout cut averages approximately 6 ft.

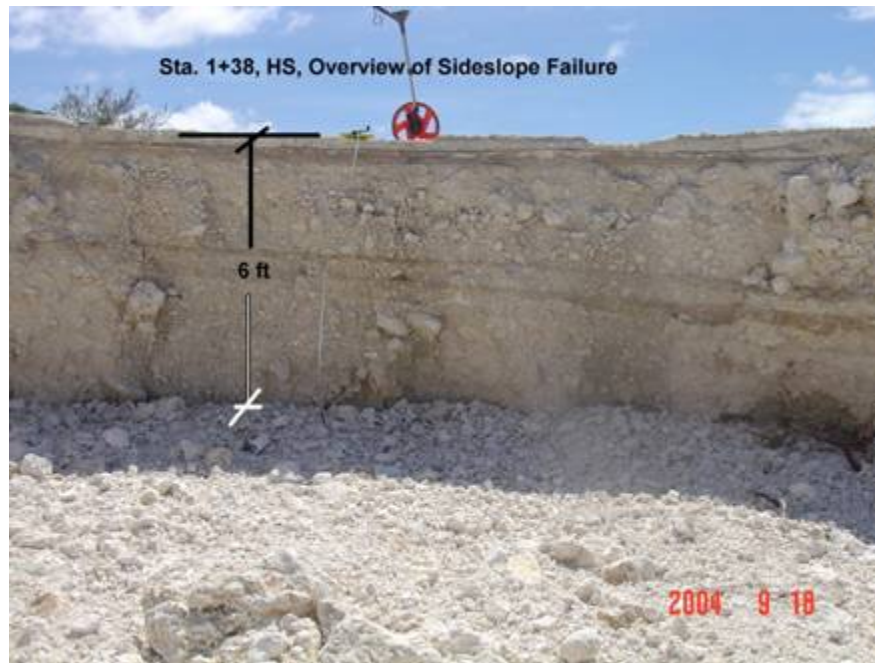
e. Sta. 1+38, HS, Same as Above.

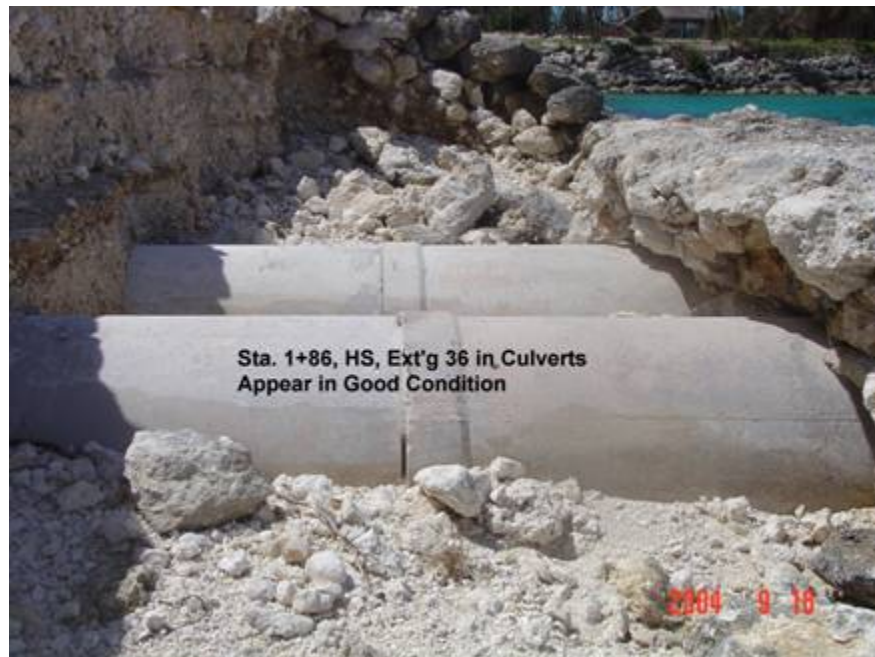
f. Sta. 1+86, HS, 36" culverts are exposed however appear in good condition.

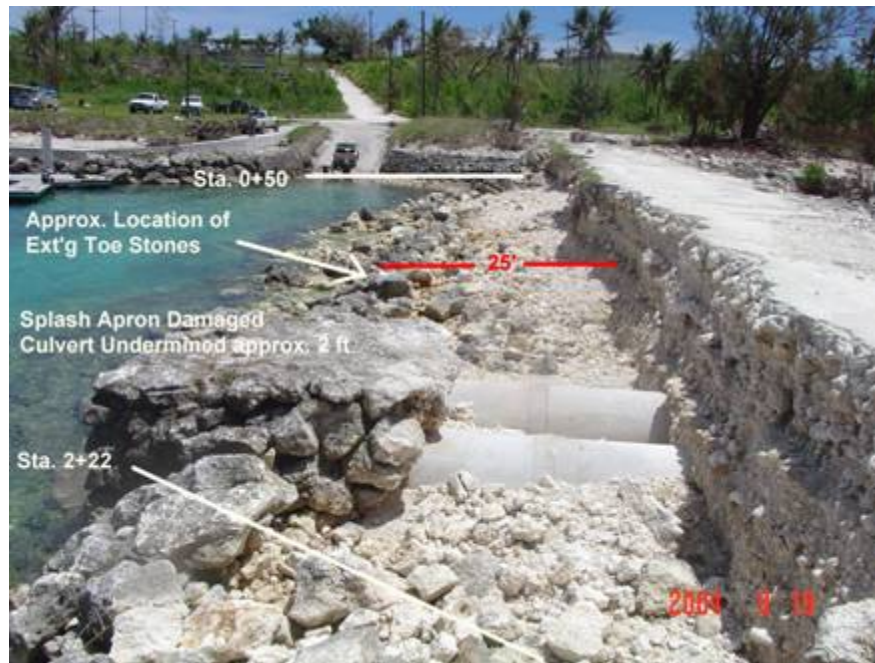
g. Sta. 2+22, HS, Sideslope failure averages 6 ft deep and approx. 25 ft from original toe stones into the revetted mole; splash apron damaged and culverts undermined approximately 2 ft.

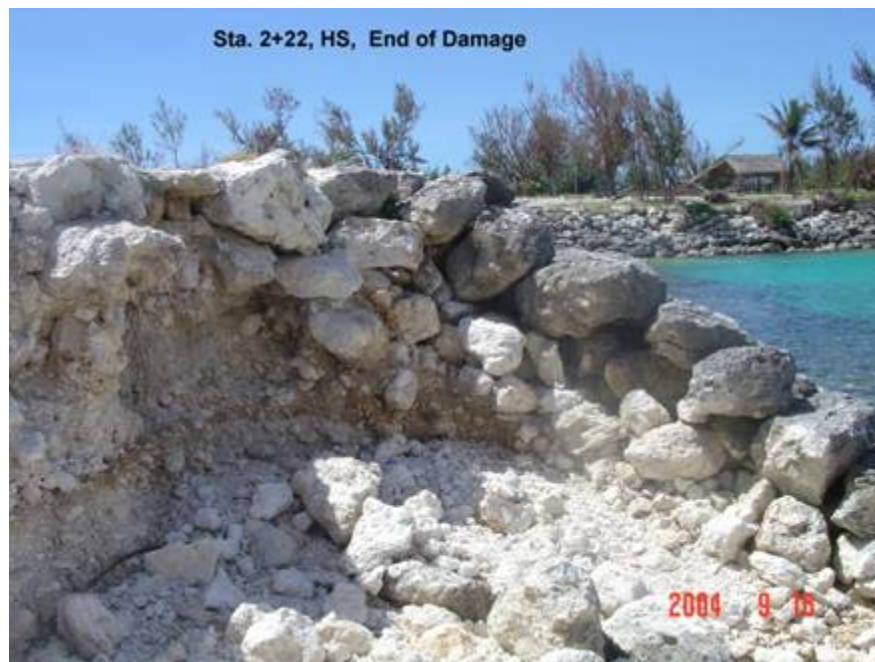
h. Sta. 2+22, HS, End of major failure.

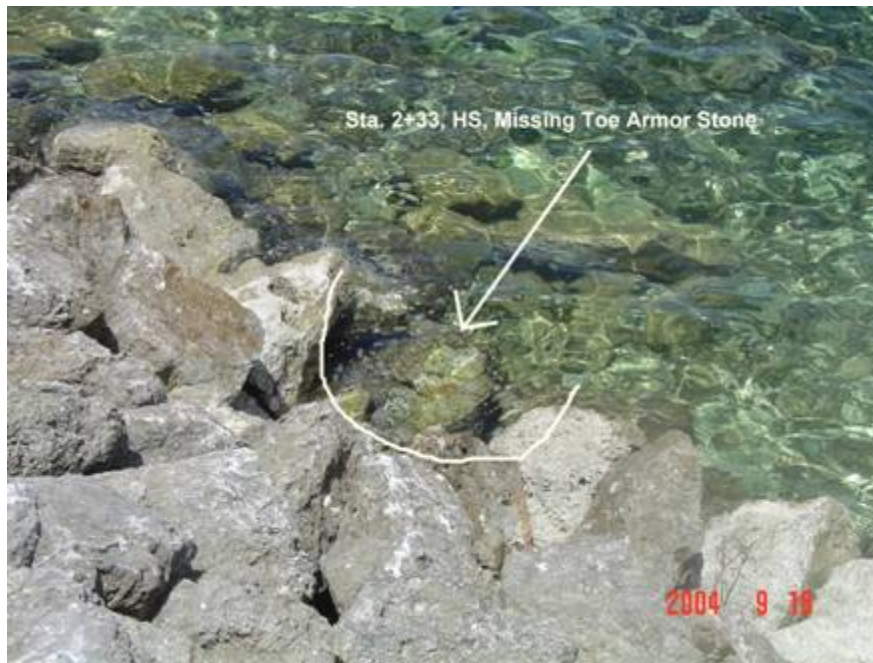
h. Sta. 2+33, HS, missing toe armor stone.

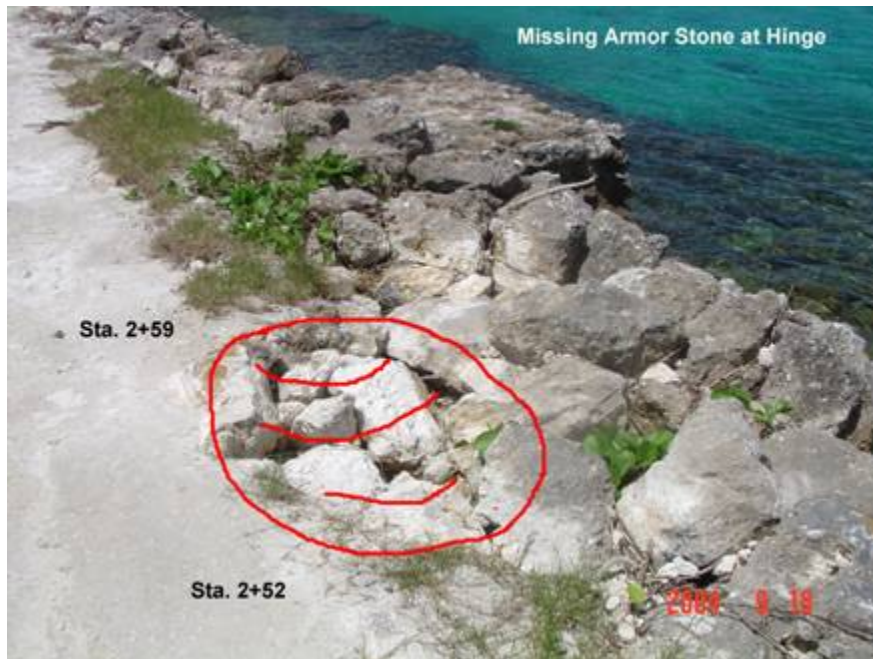
i. Sta. 2+52 to Sta. 2+59, HS, missing armor stones at the hinge of the sideslope.

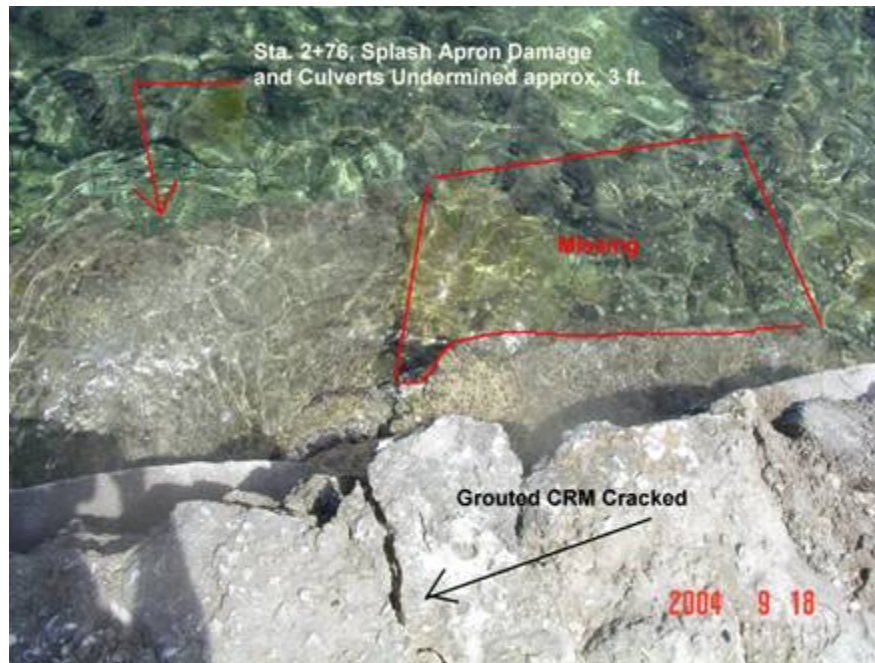
j. Sta. 2+76 HS, Splash apron damages and culverts undermined approx. 3 ft.

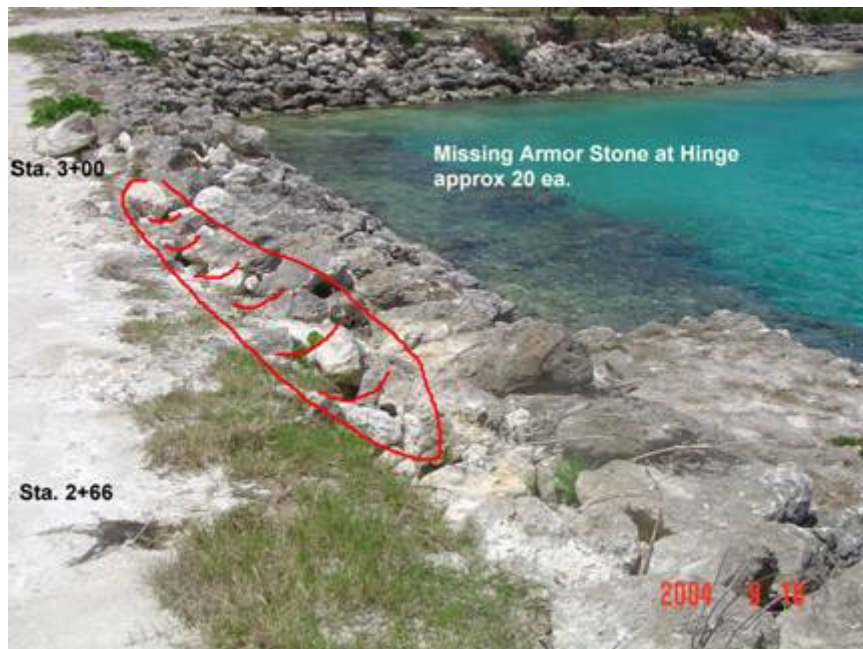
k. Sta. 2+66 to Sta. 3+00, HS, approximately 20 ea. missing armor stones from the hinge of the sideslope.

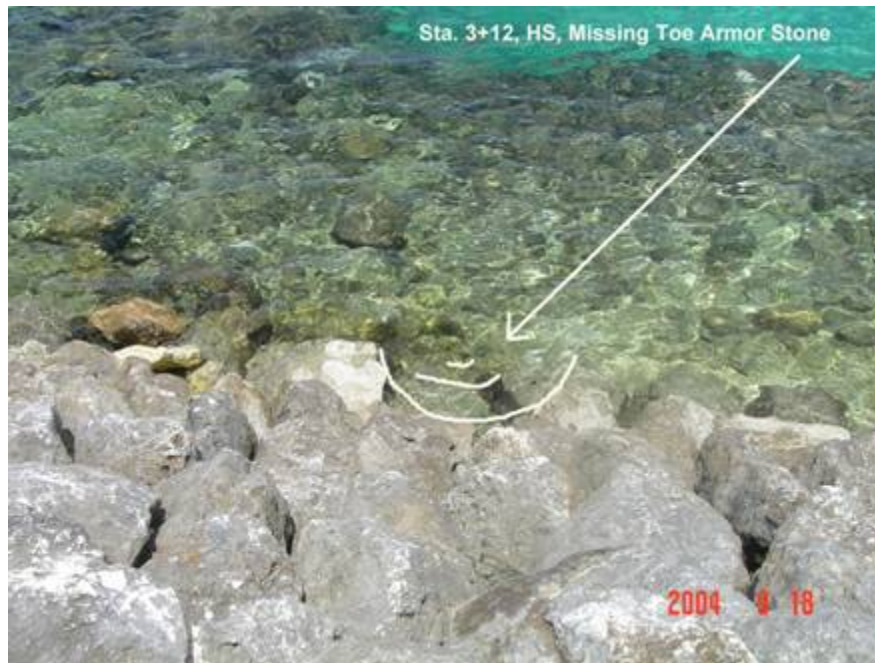
1. Sta. 3+12, HS, missing toe armor stone.

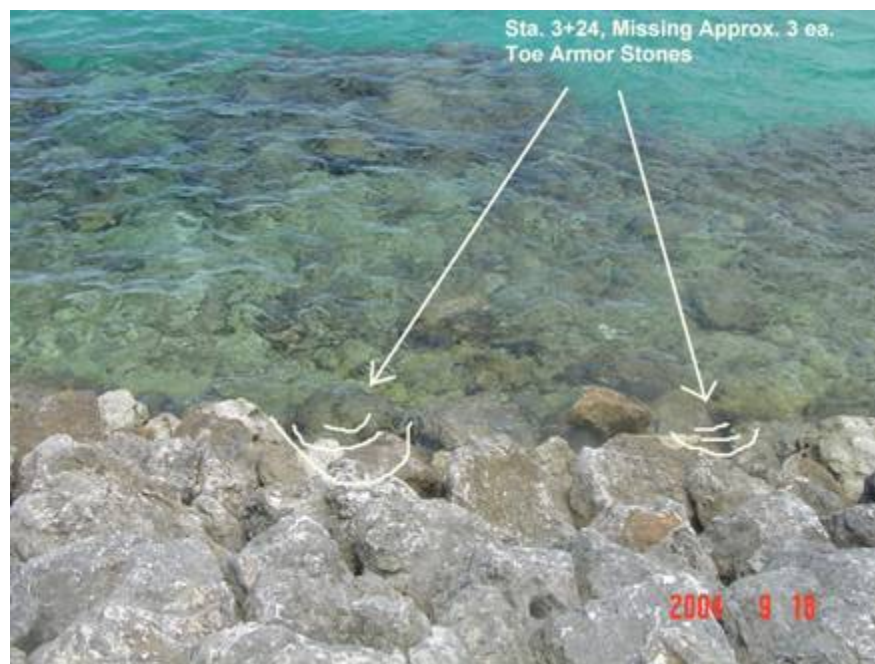
m. Sta. 3+24, approx. 3 ea. missing toe armor stones.

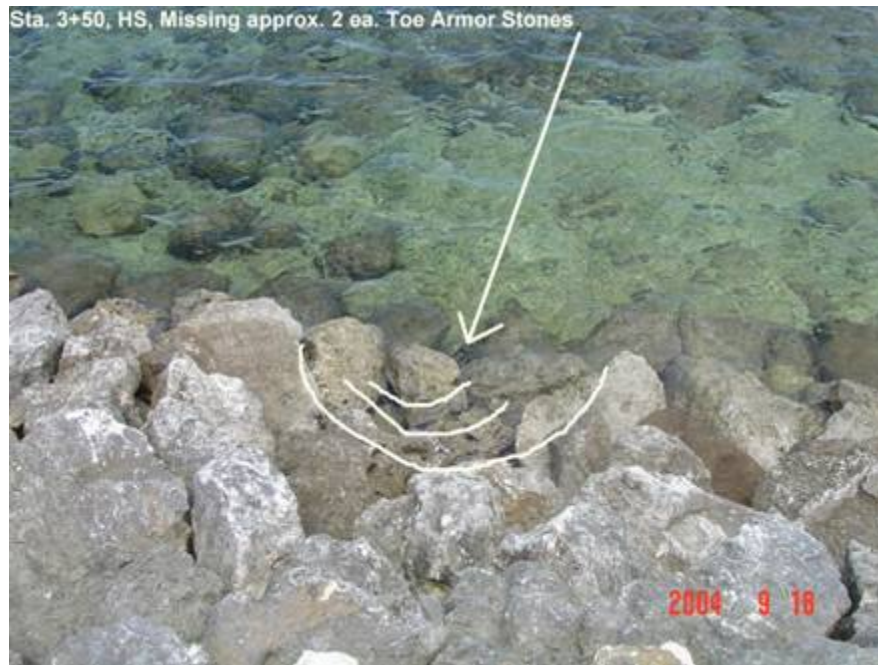
n. Sta. 3+50, HS, 2 ea. missing toe armor stones.

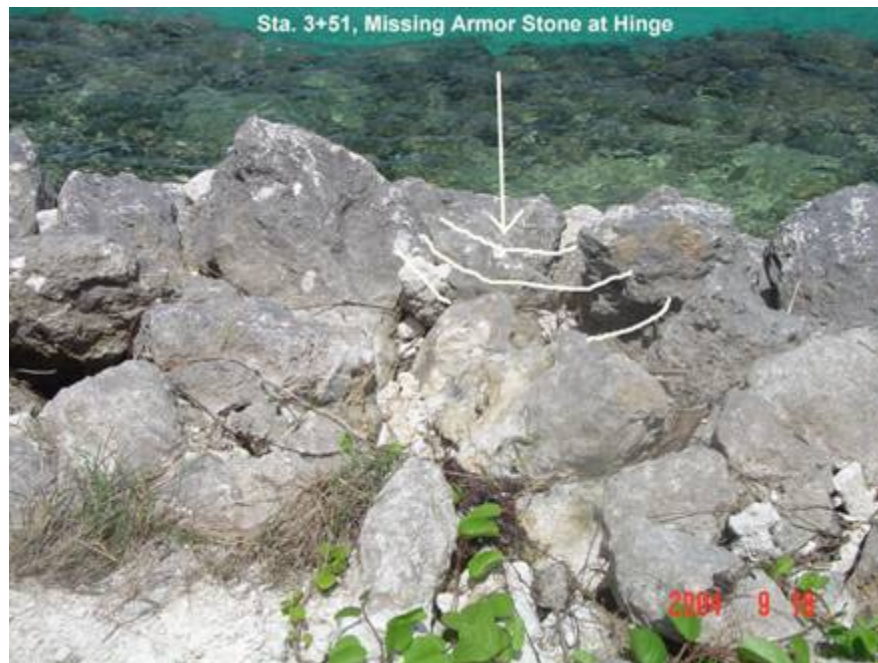
o. Sta. 3+51, HS, 1 ea. missing armor stone.

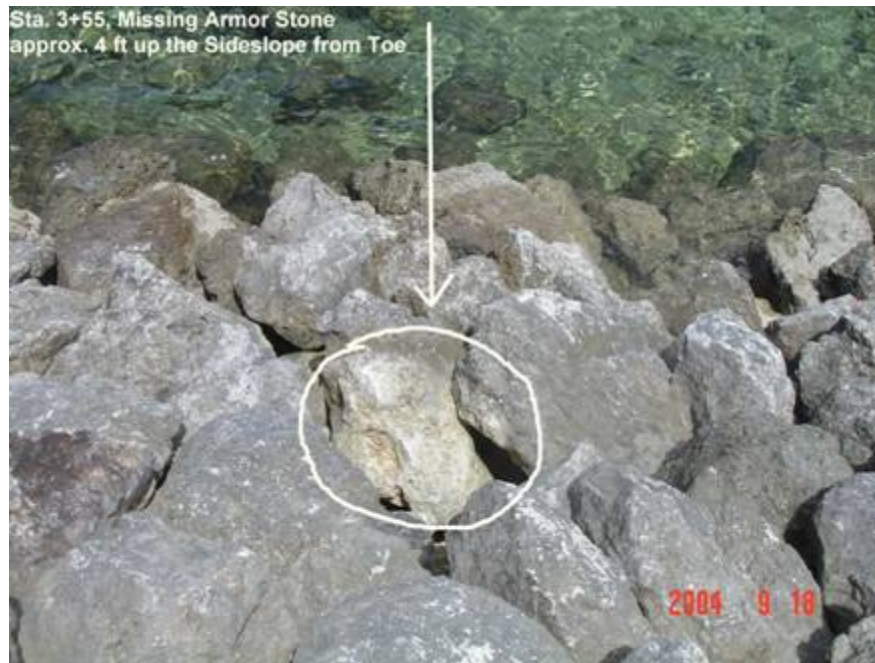
p. Sta. 3+55, missing armor stone approximately 4 ft up the sideslope from the toe.

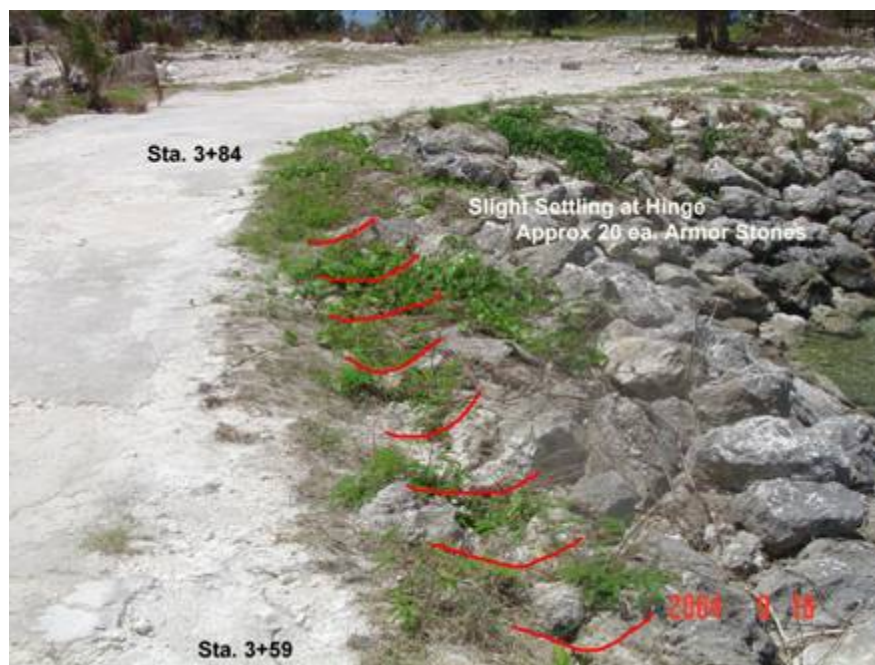
q. Sta. 3+59 to Sta. 3+84, HS, approximately 20 ea. missing armor stone to the hinge if the sideslope.

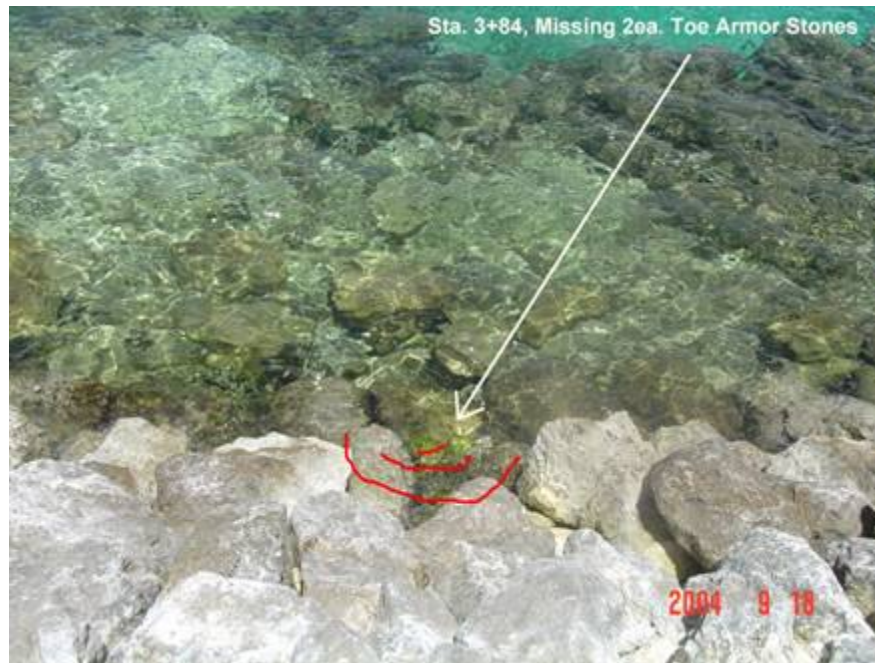
u. Sta. 3+84, missing toe armor stone.

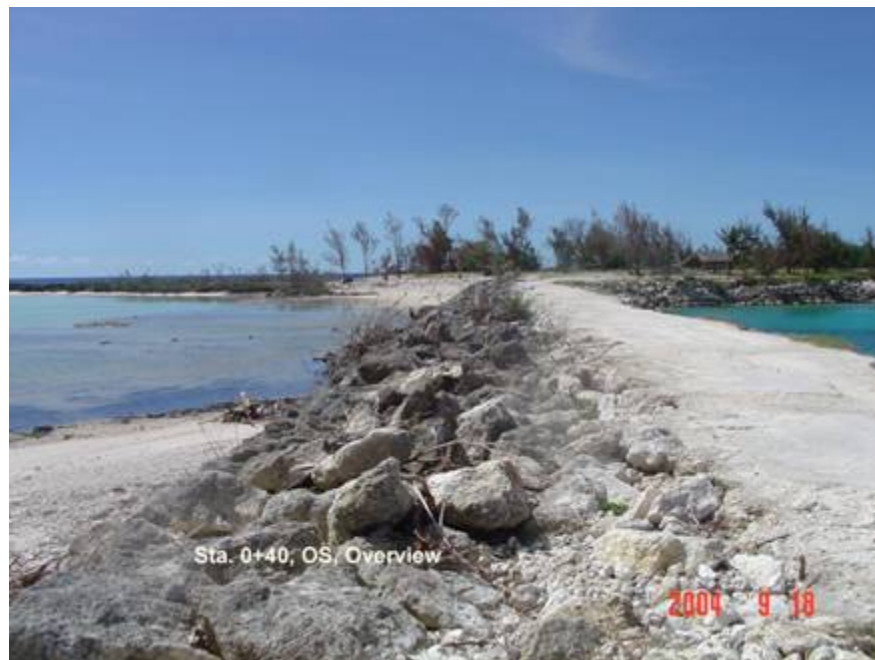
a. Sta. 0+40, OS, 1st visible armor stones.

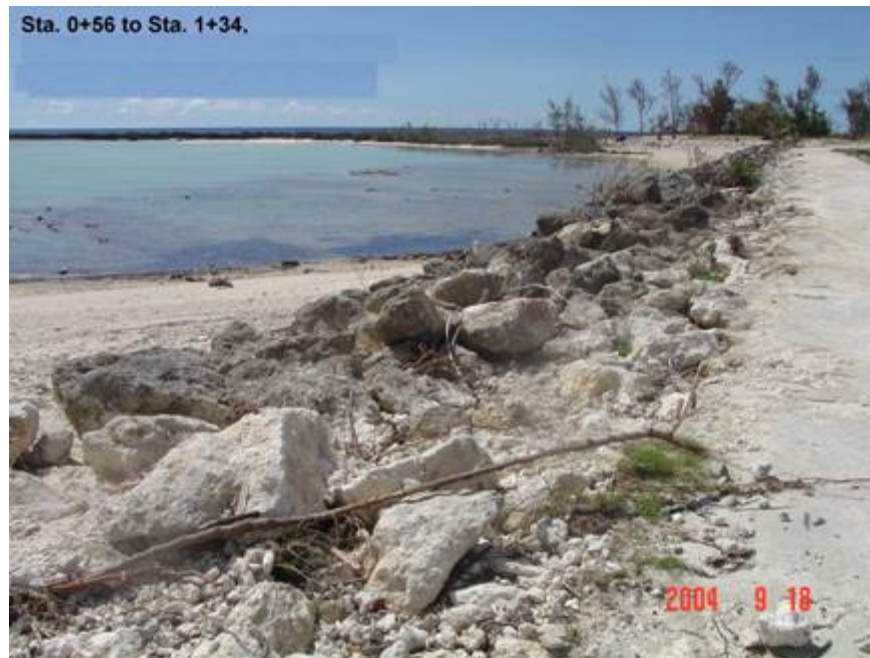
b. Sta. 0+56 to Sta. 1+34, OS, approximately 15 ea. flipped armor stones and approximately 30 ea. missing armor stones.

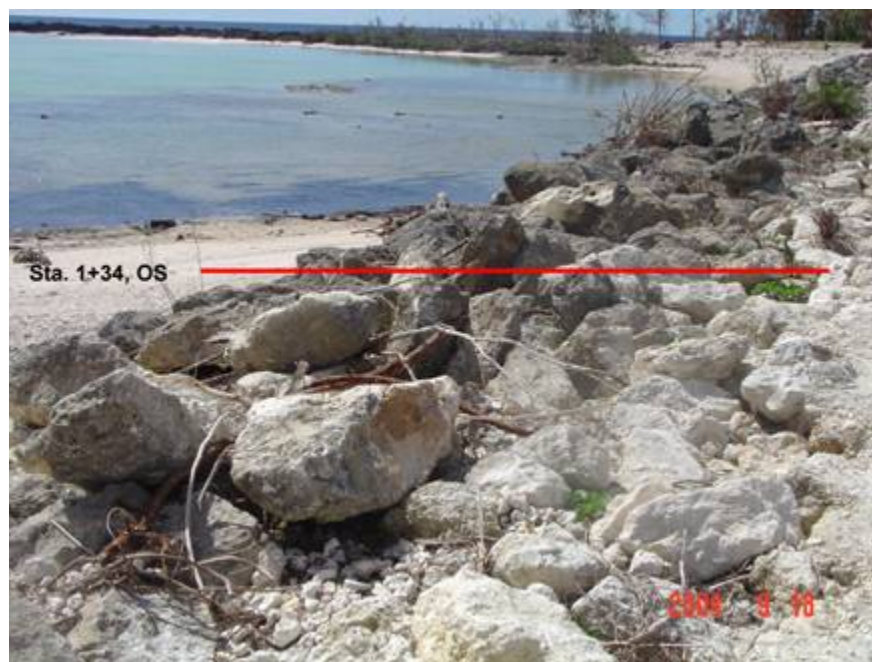
c. Sta. 1+34, OS, overview.

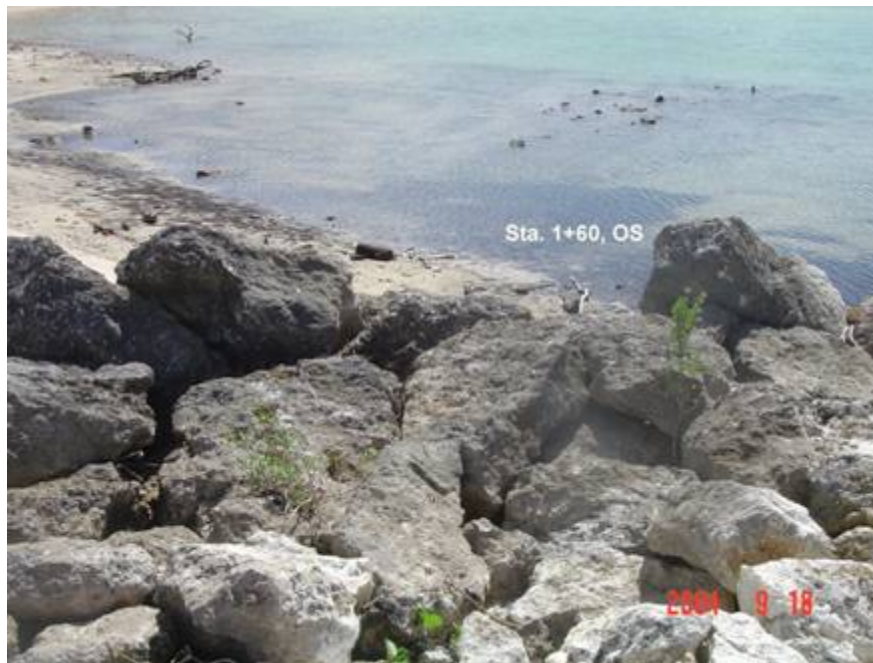
d. Sta. 1+60, OS, overview.

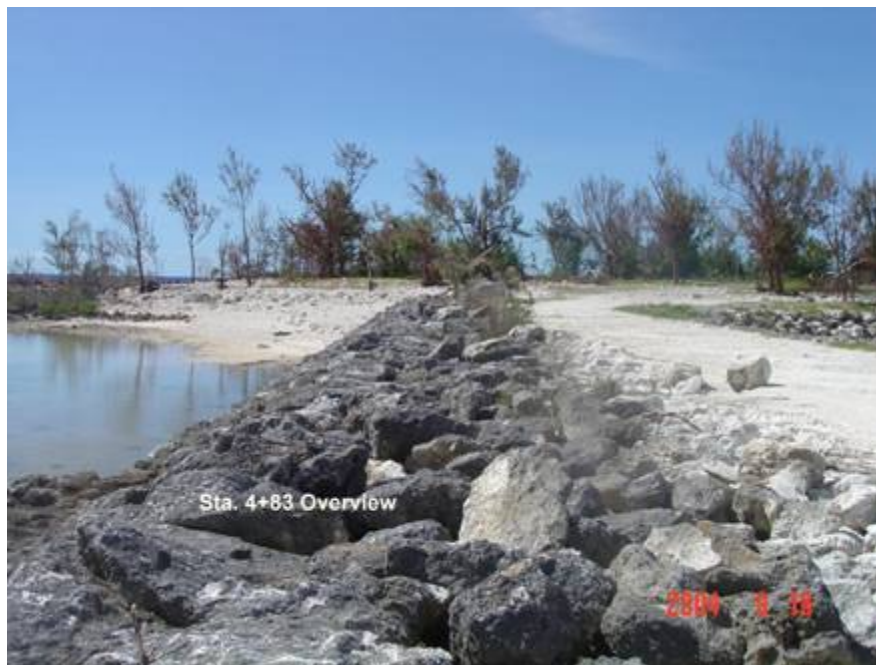
g. Sta. 4+83, OS, overview.

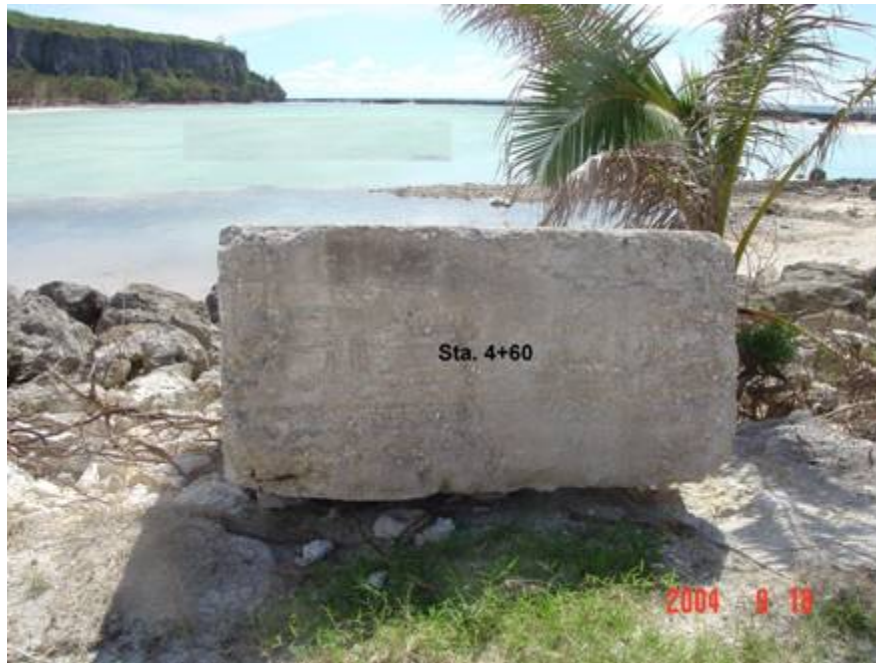
h. Sta. 4+60, OS, concrete block and coconut tree on structure.

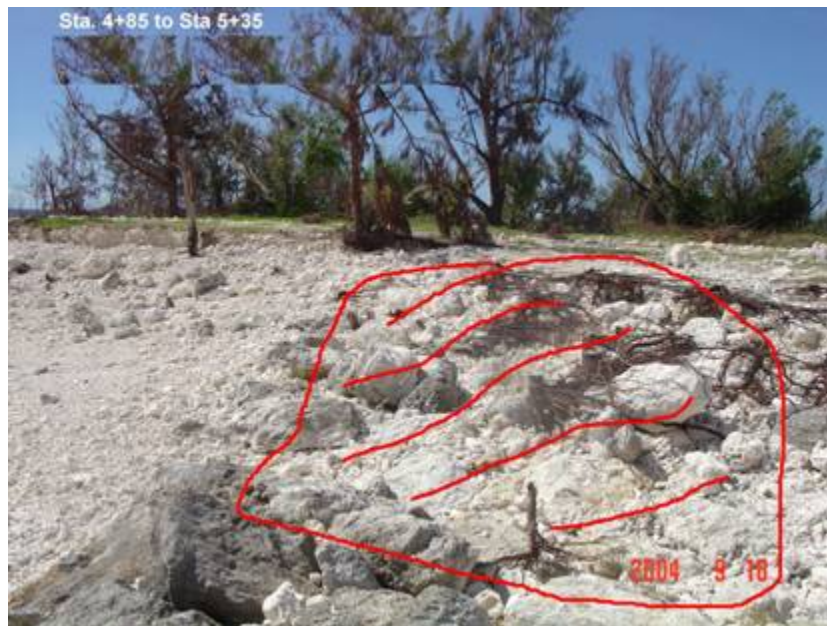
i. Sta. 4+85 to Sta. 5+35, OS, tree roots and armor stones in poor contact at identified area.

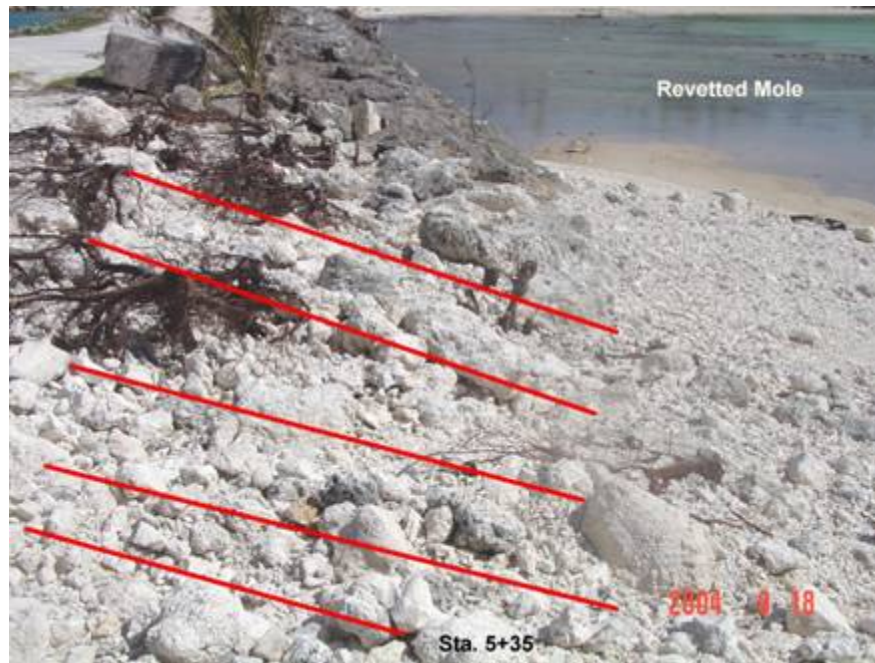
j. Sta. 5+35, OS, overview photo.

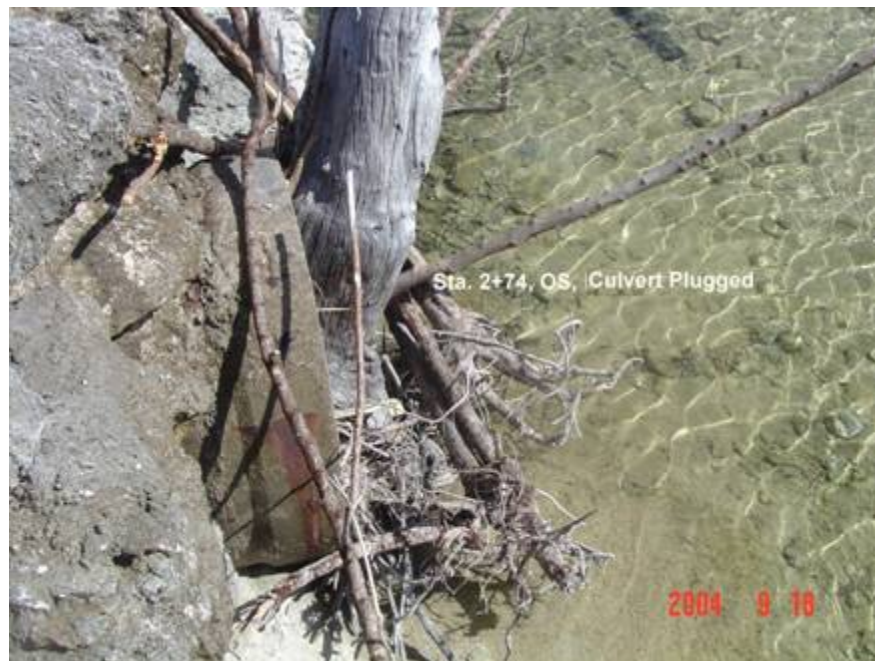
k. Sta. 2+74, OS, trees in culverts.

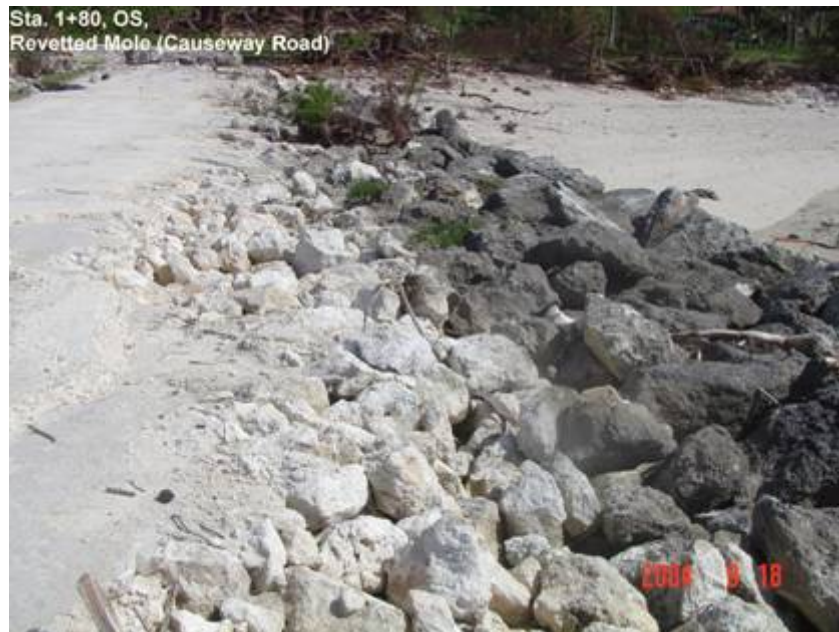
1. Sta. 1+80, OS, tree and revetted mole (causeways surface rough) Photo is typical throughout.
